FEED HOPPER ADJUSTMENT AND MAINTENANCE

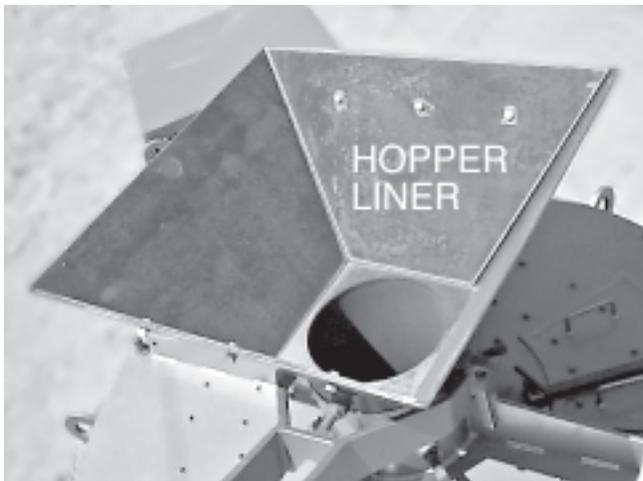
Replace the feed hopper liners when they wear through and the hopper starts to appear behind them. Simply remove the three cap screws, lift off the plate, and replace it. Most likely the cap screws will need replacement also.

Feed hopper liner

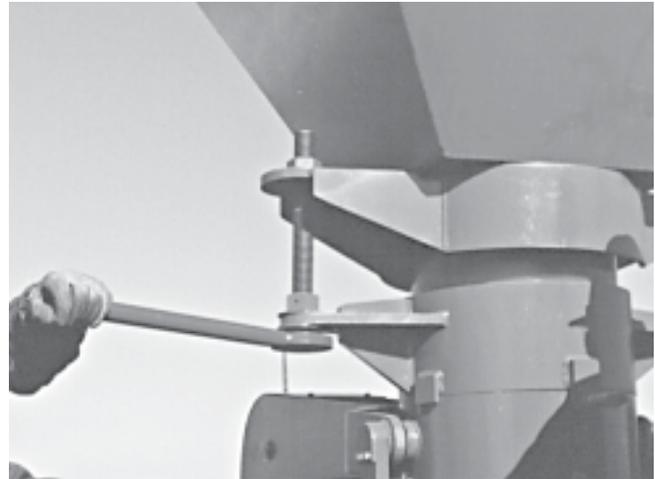
1. Loosen the lid screws.
2. Use the wrench provided to rotate the adjustment screws. Turn the screws clockwise to lower the hopper and counterclockwise to raise the hopper. If the hopper needs to move a large distance, alternate between screws by giving one a turn then the other a turn.
3. Secure the feed tube in position and center it in the rotor by tightening the square head lid screws.

New style hopper adjustment

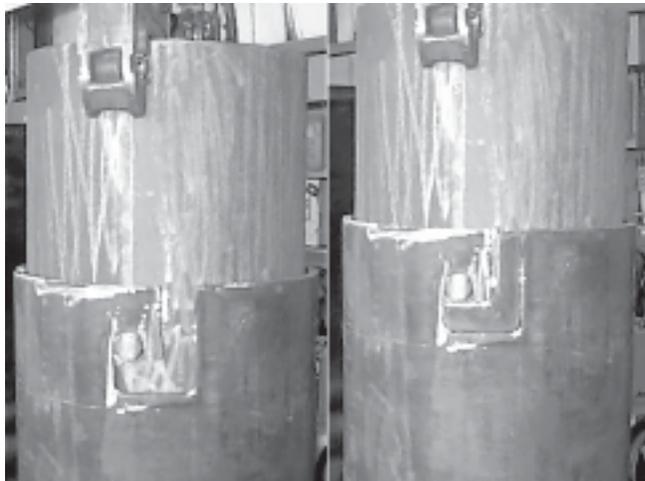
The feed tube liner installs in the feed tube through four J-shaped slots. Once installed, the tabs cut from the slots are tack welded back in place with short, low penetration welds. To remove the feed tube, grind off the welds and remove the tabs. Insert the new feed tube liner and tack weld the tabs back in place.

Tab removed

Tab tacked in place

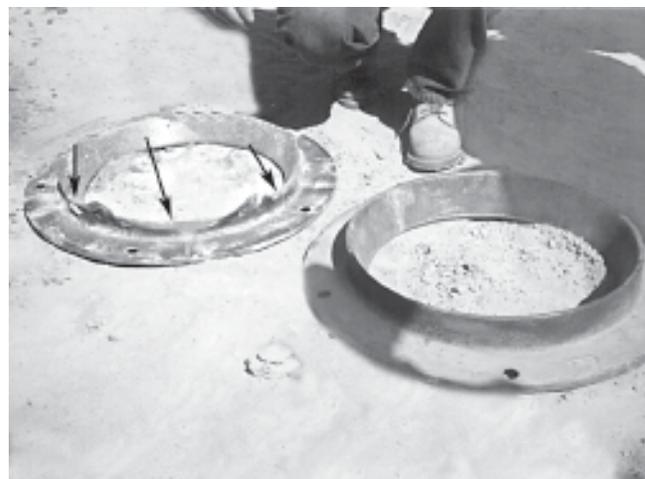
The feed tube liner above caused excessive tube flange wear. This tube flange lasted only 16 hours.

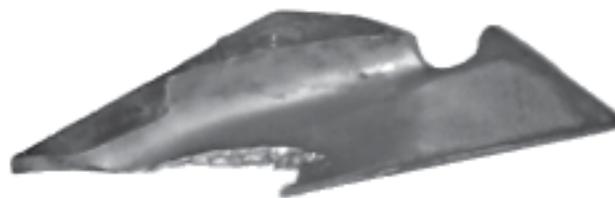
This upper ramp was in the same rotor as the tube flange pictured above.

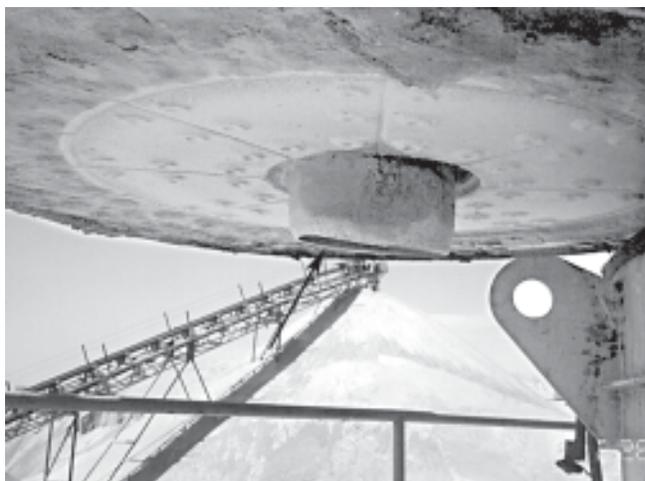
Non square feed tube liner improperly directs material into the rotor. This results in excess tube flange and upper ramp liner wear.
